FLOOD PLAIN INFORMATION

YELLOWSTONE RIVER

LIVINGSTON MONTANA

PREPARED FOR
PARK COUNTY
AND
MONTANA DEPARTMENT OF NATURAL RESOURCES
BY
DEPARTMENT OF THE ARMY — OMAHA DISTRICT — CORPS OF ENGINEERS 68102
NOVEMBER 1974

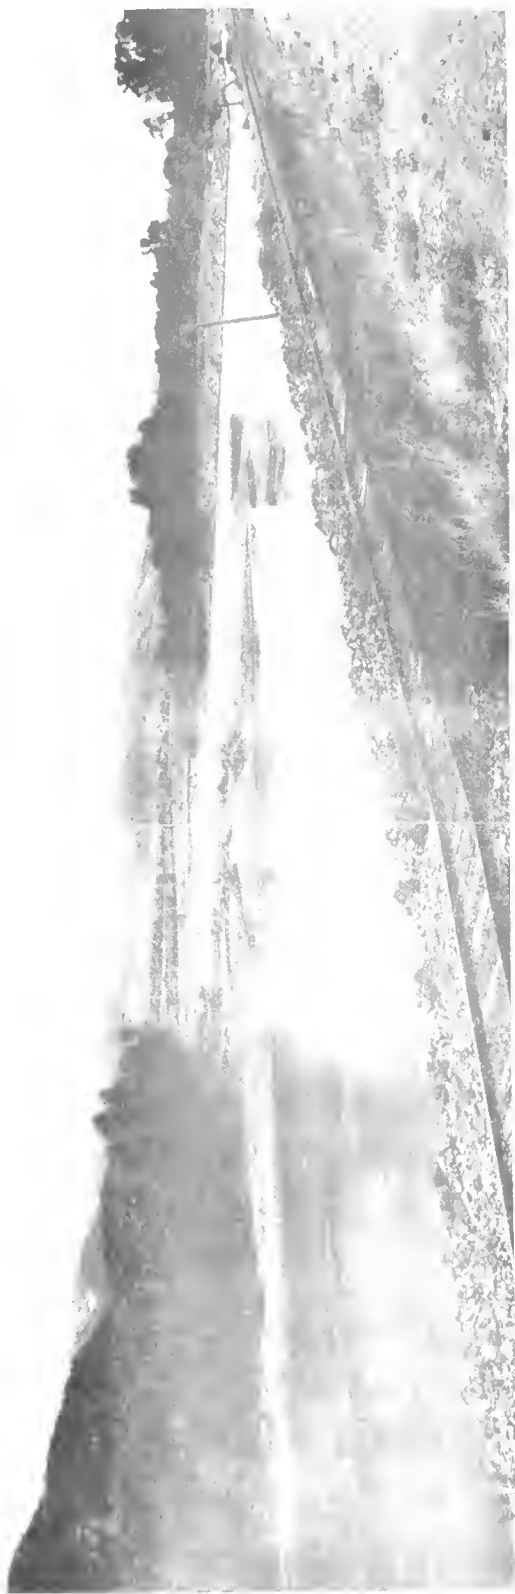
Figure 1. Looking upstream from 500 feet downstream of reference point 3. September 1974.

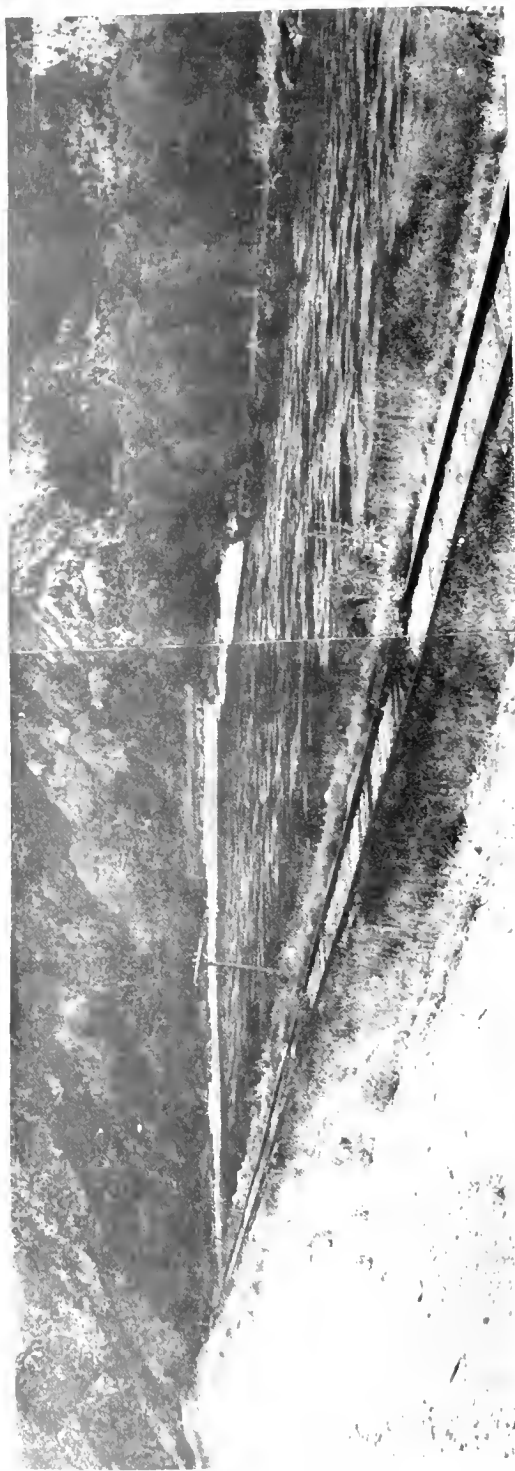
Figure 2. Looking downstream from 500 feet upstream of reference point 3. September 1974.

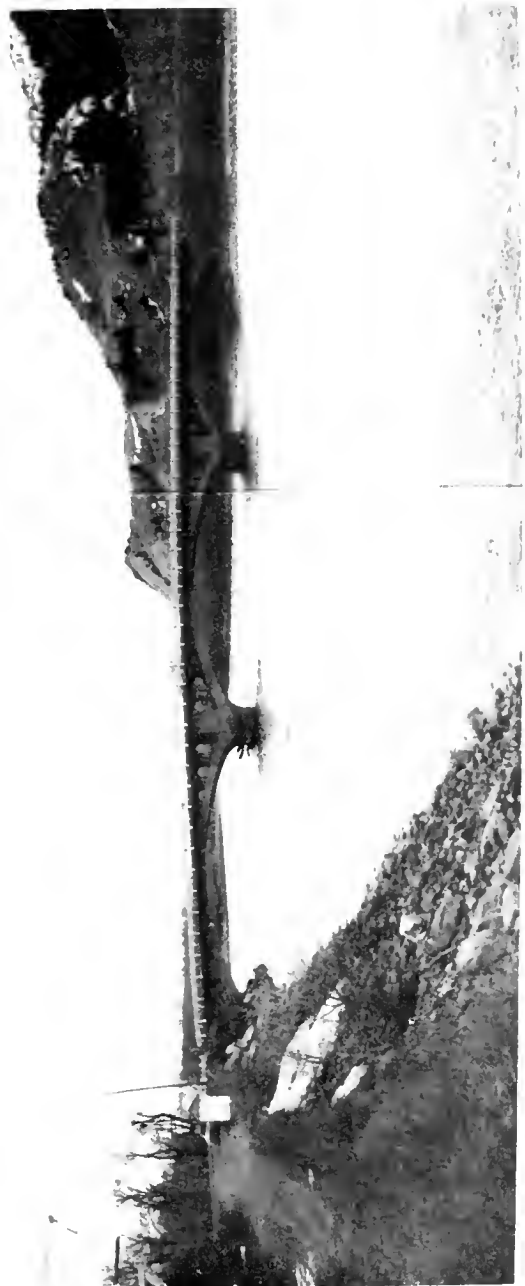
Figure 3. Looking upstream at the Carter Bridge (reference point 5) from the right bank. February 1974.

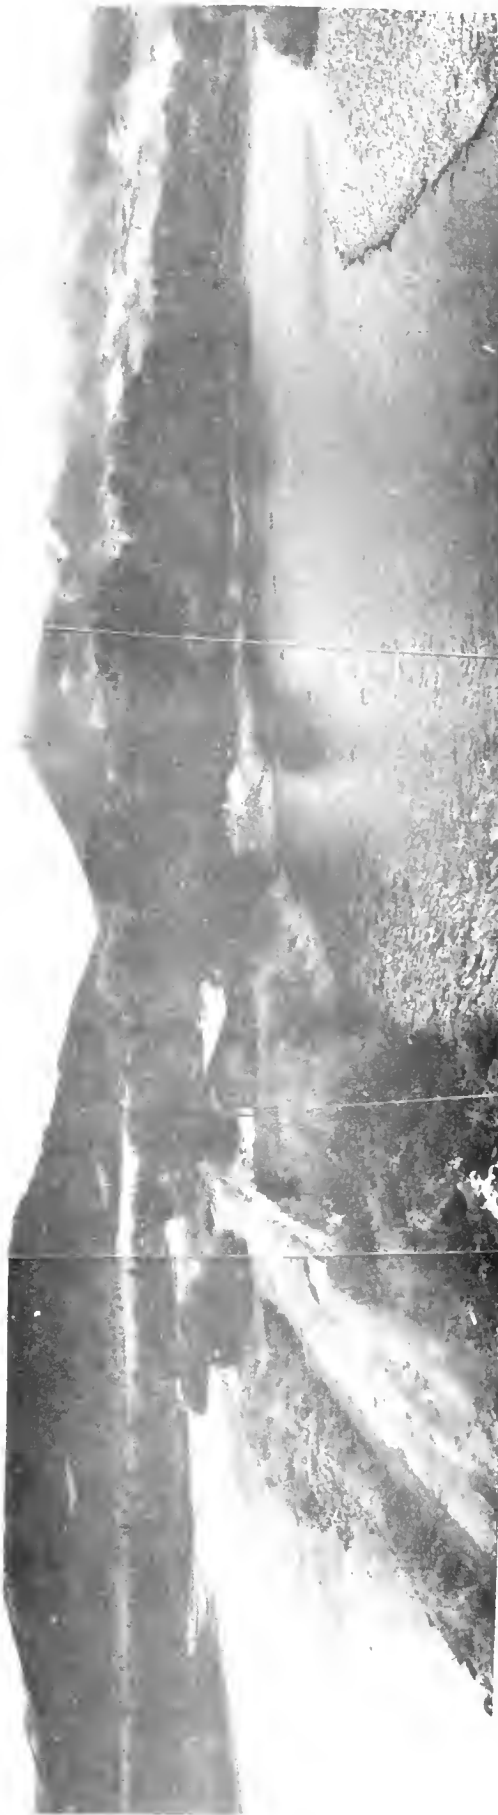
Figure 4. Looking upstream from the Interstate 90 bridge (reference point 13) at Siebeck Island. September 1974.

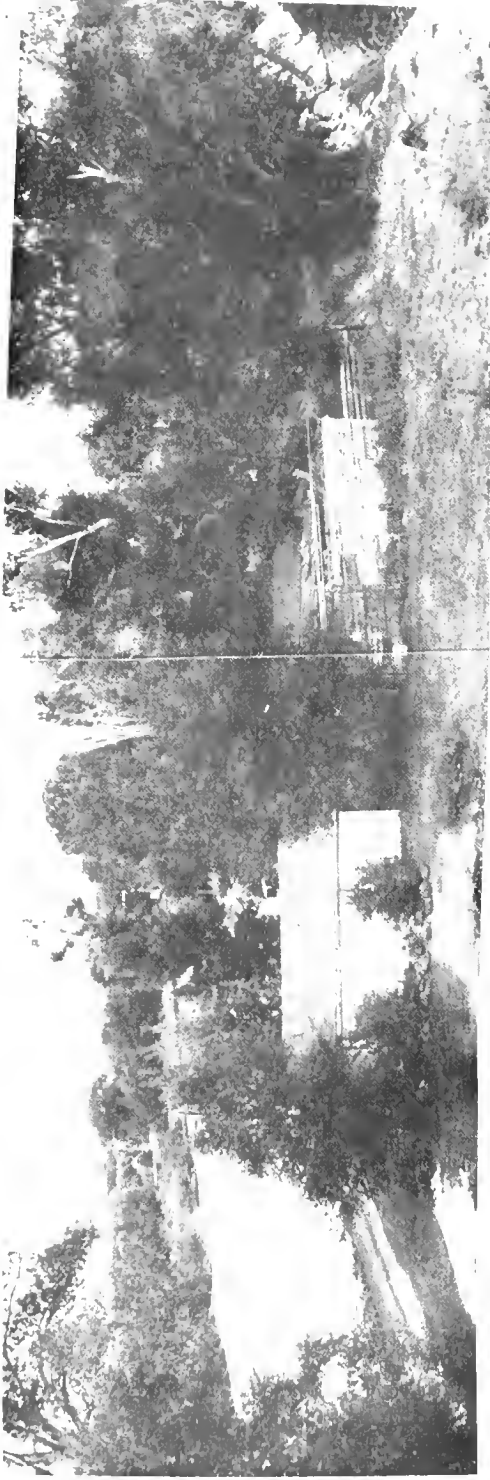
Figure 5. Looking downstream from the Interstate 90 Bridge (reference point 13) at Ninth Street Island. September 1974. Note what appears to be sandbags adjacent to the white building evidently remaining from the flood of June 1974. Note also that the right edge of Figure 5 blends with the left edge of Figure 6 making one continuous photograph.

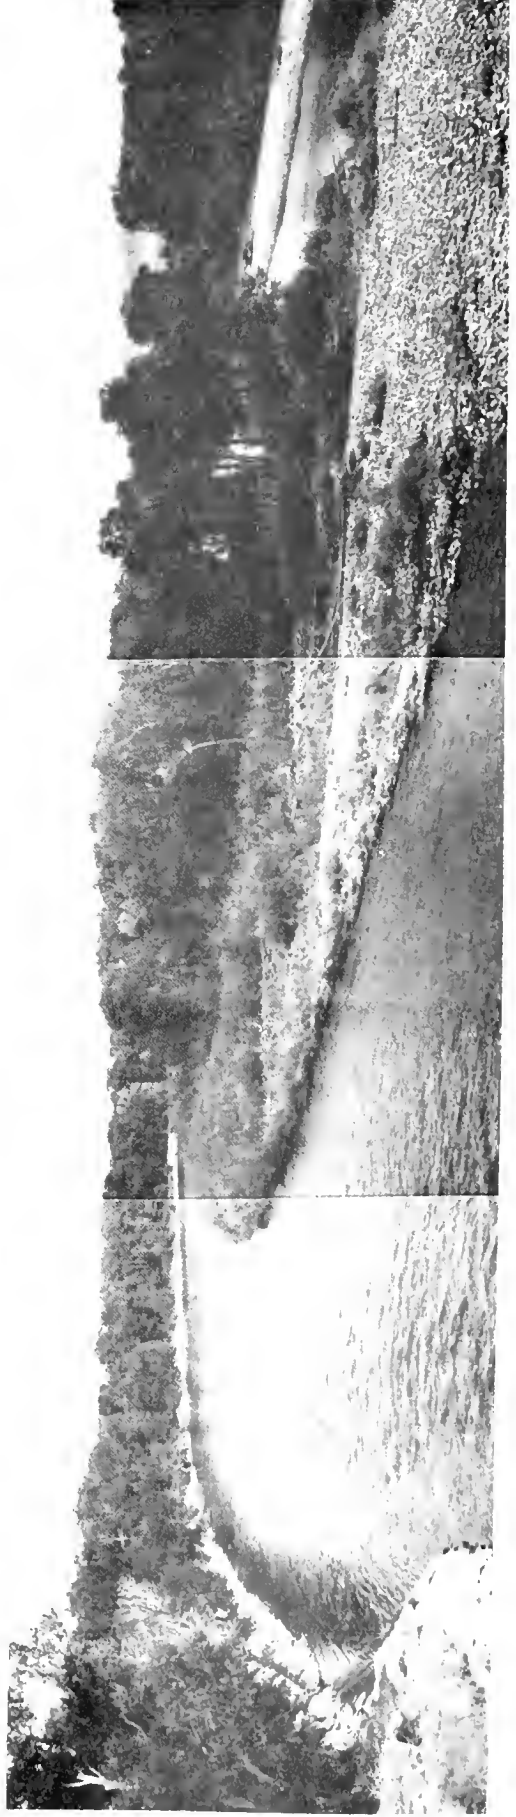
Figure 6. Looking downstream from the Interstate 90 Bridge (reference point 13) at Ninth Street Island at the left and in the far background.

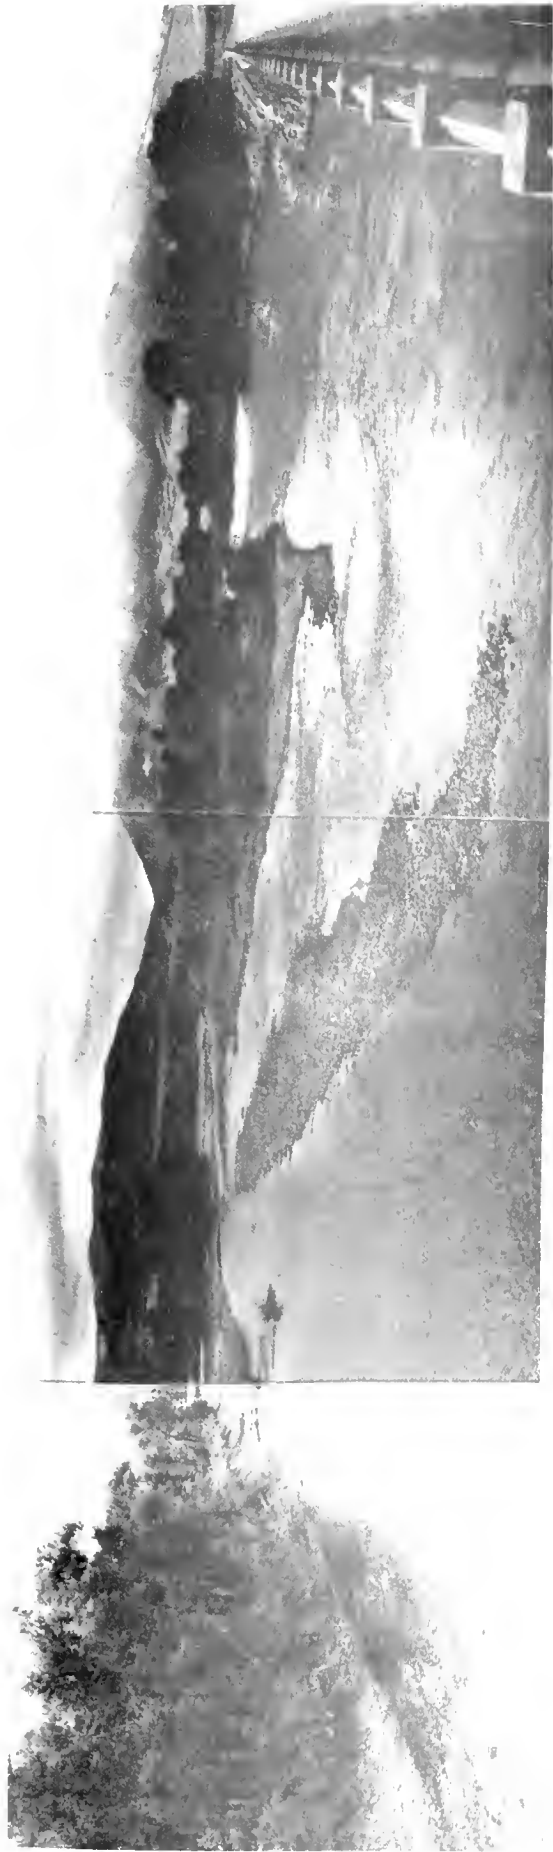
Figure 7. Looking upstream from the U.S. Highway 10 bridge (reference point 22). September 1974.

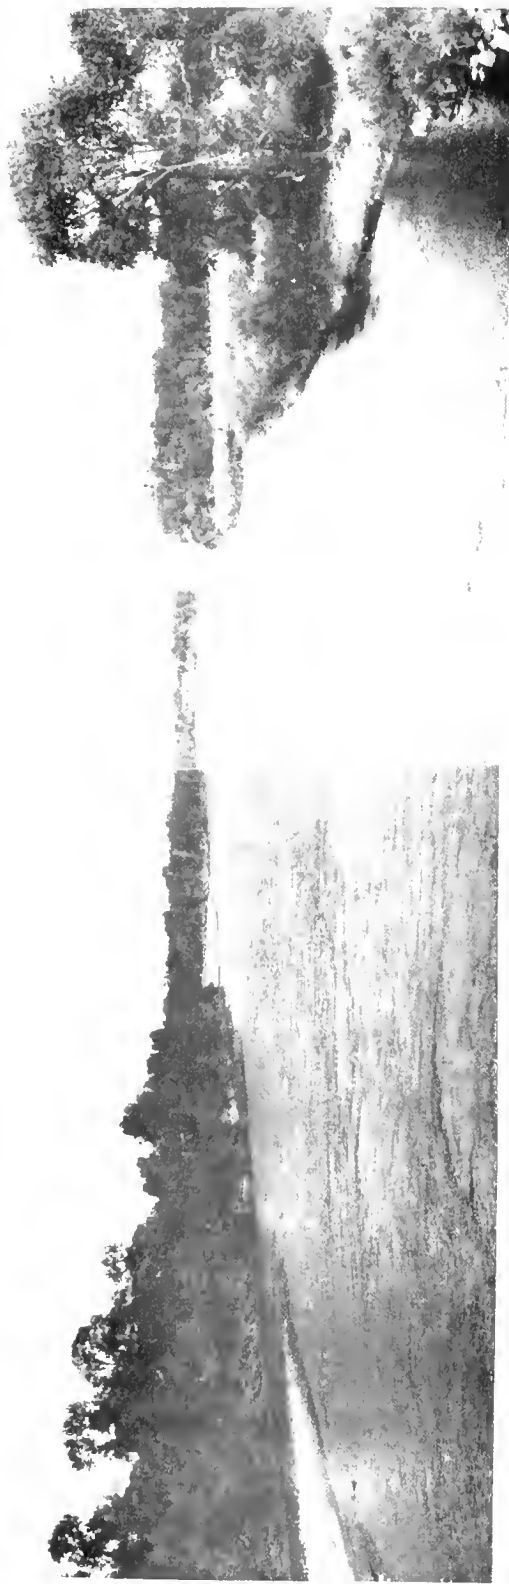
Figure 8. Looking downstream from the Burlington Northern Railroad bridge (reference point 23). September 1974.

the flood of June 1974, the Burlington Northern Railroad bridge (Reference point 23) sustained damage when the large floodflow passing through the bridge caused the south portion of the middle bridge pier to crack and settle.

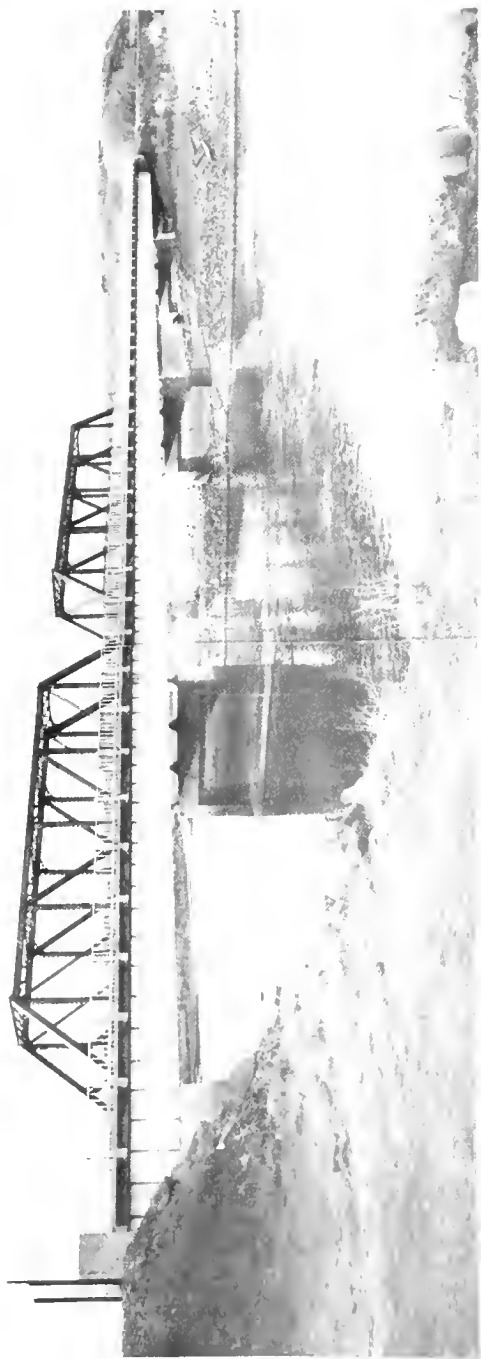
Figure 9. Looking upstream at the U.S. Highway 89 bridge and the Burlington Northern Railroad bridge (reference points 30 and 29 respectively). February 1974.

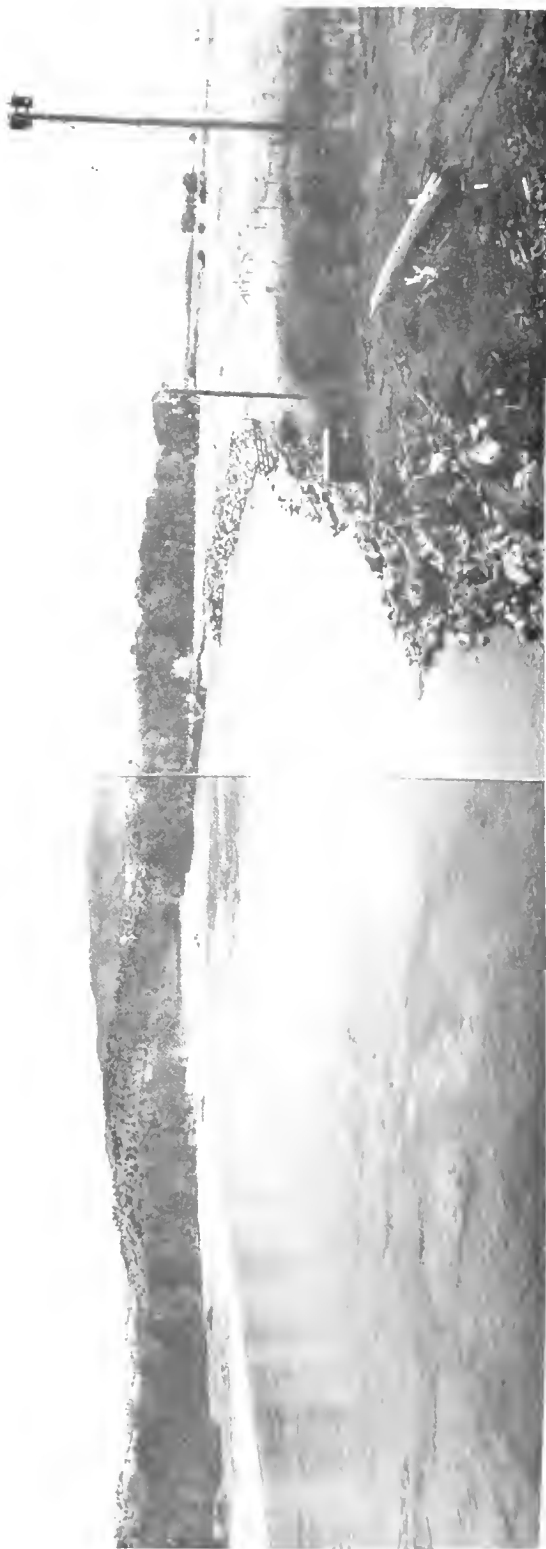
Figure 10. Looking downstream from the U.S. Highway 89 bridge (reference point 30). September 1974.

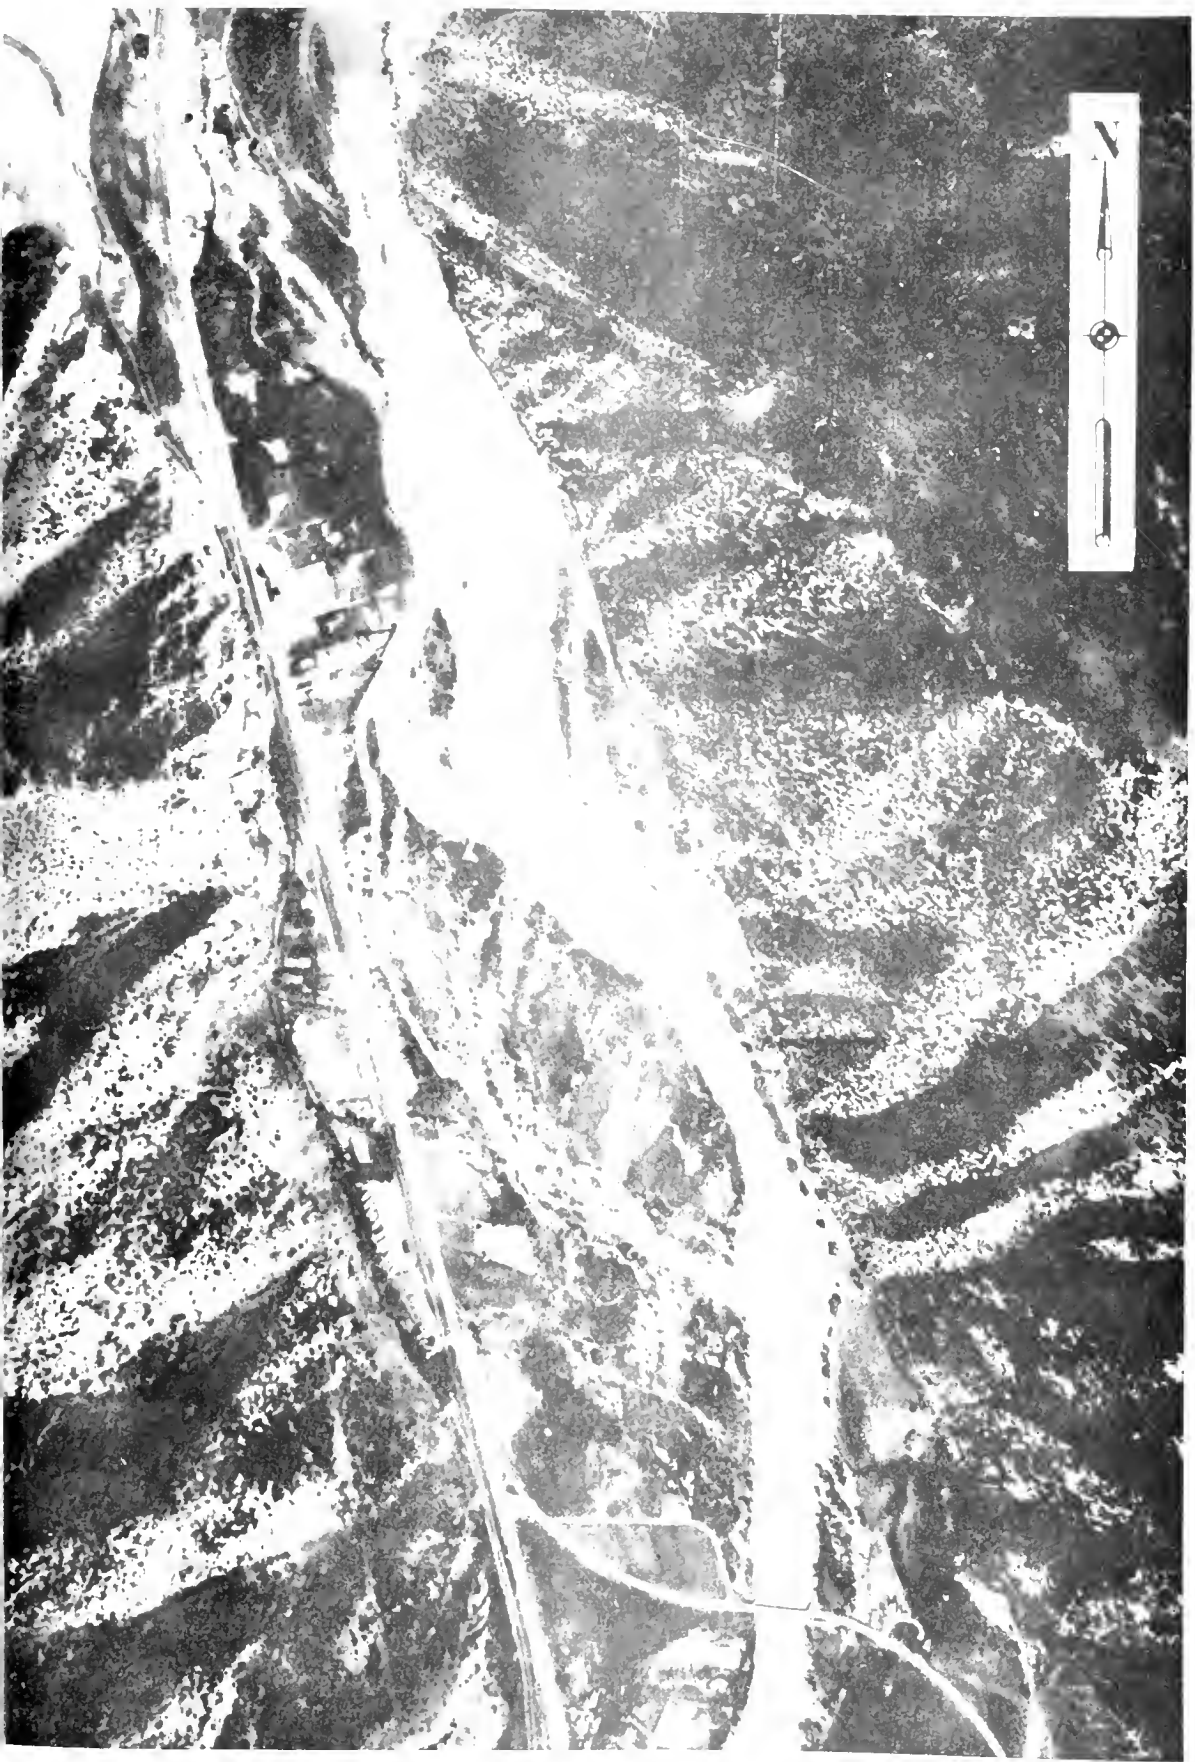
Figure 11. Yellowstone River in the vicinity of Livingston, Montana. The Carter Bridge (reference point 5) is in the southeast corner of the photograph.

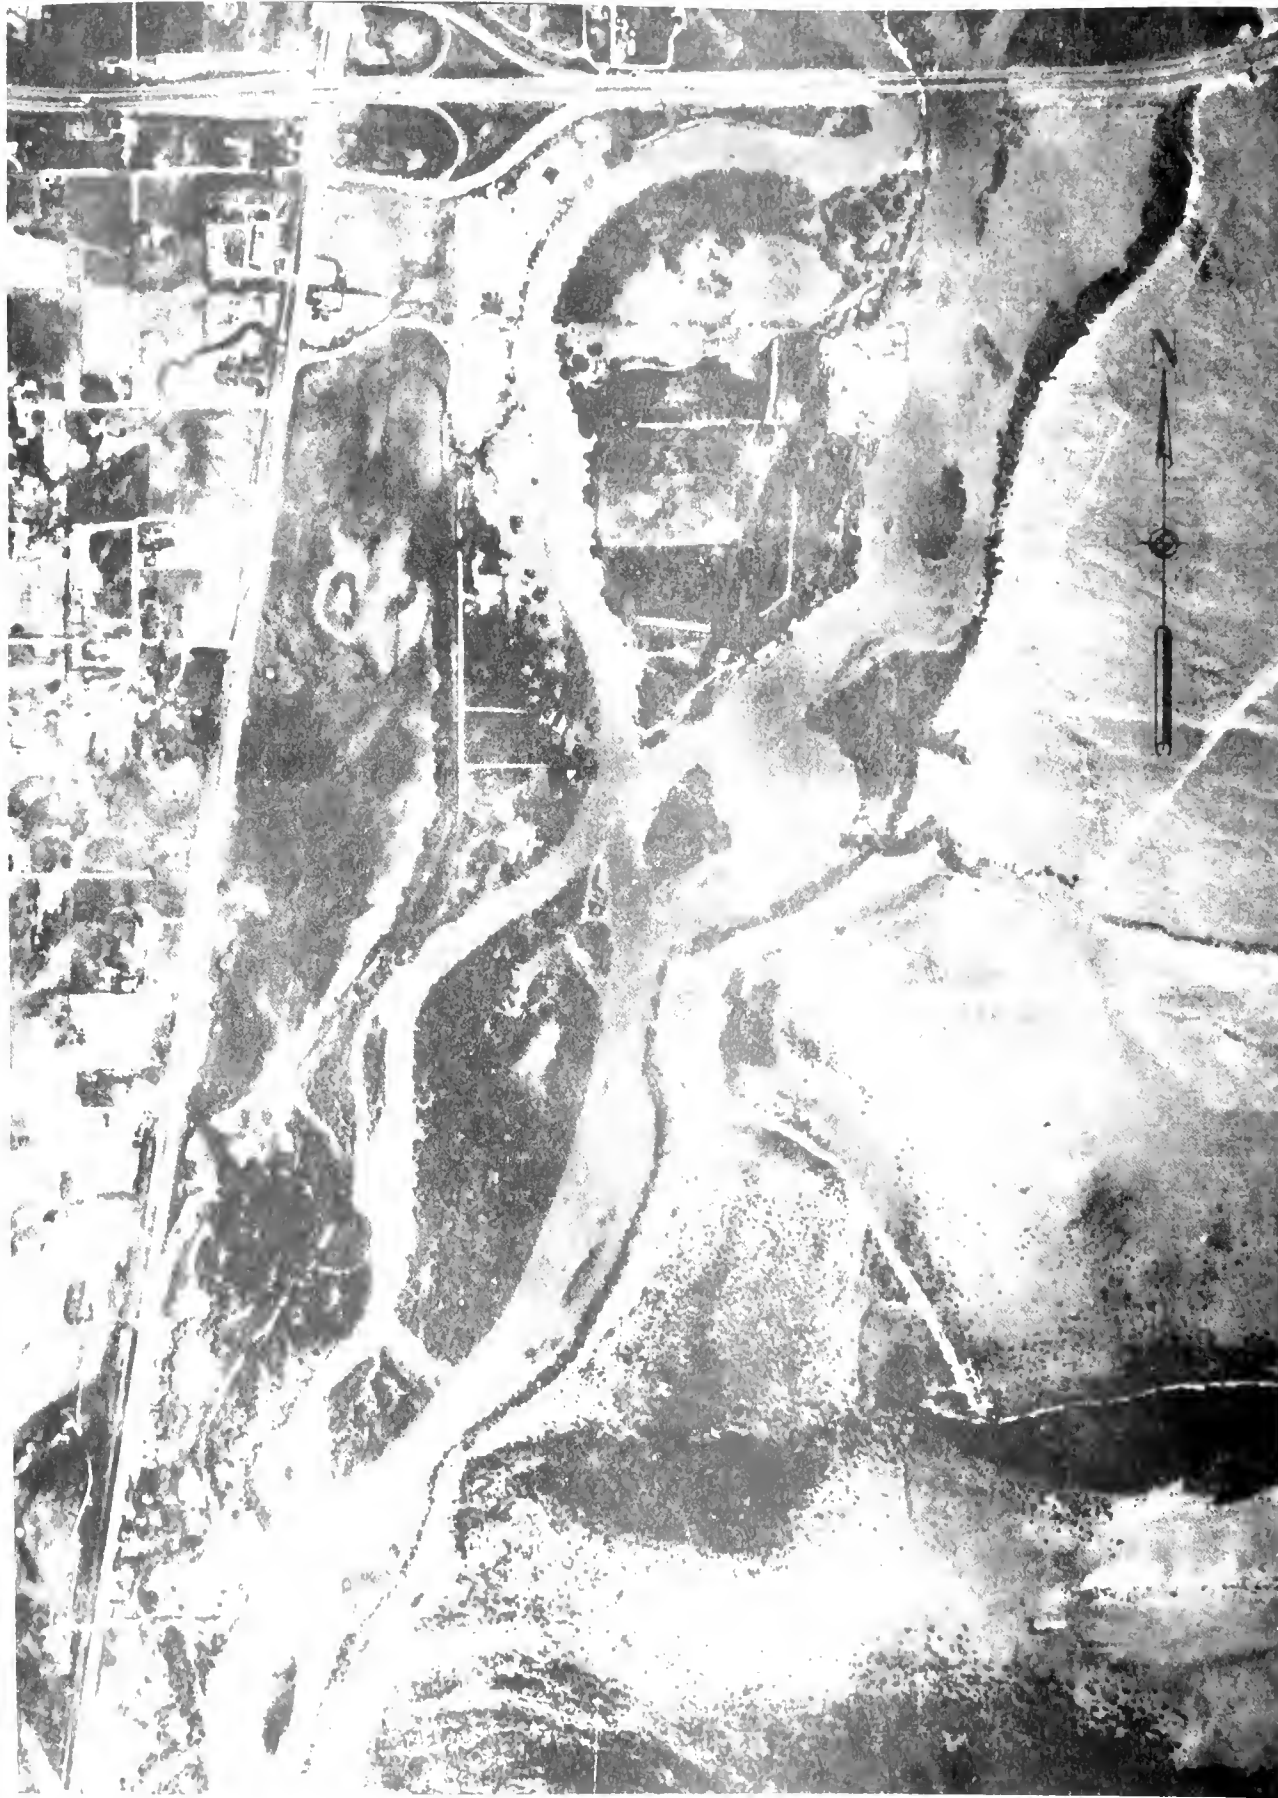
Figure 12. Yellowstone River in the vicinity of Livingston, Montana. Interstate 90 is at the extreme north

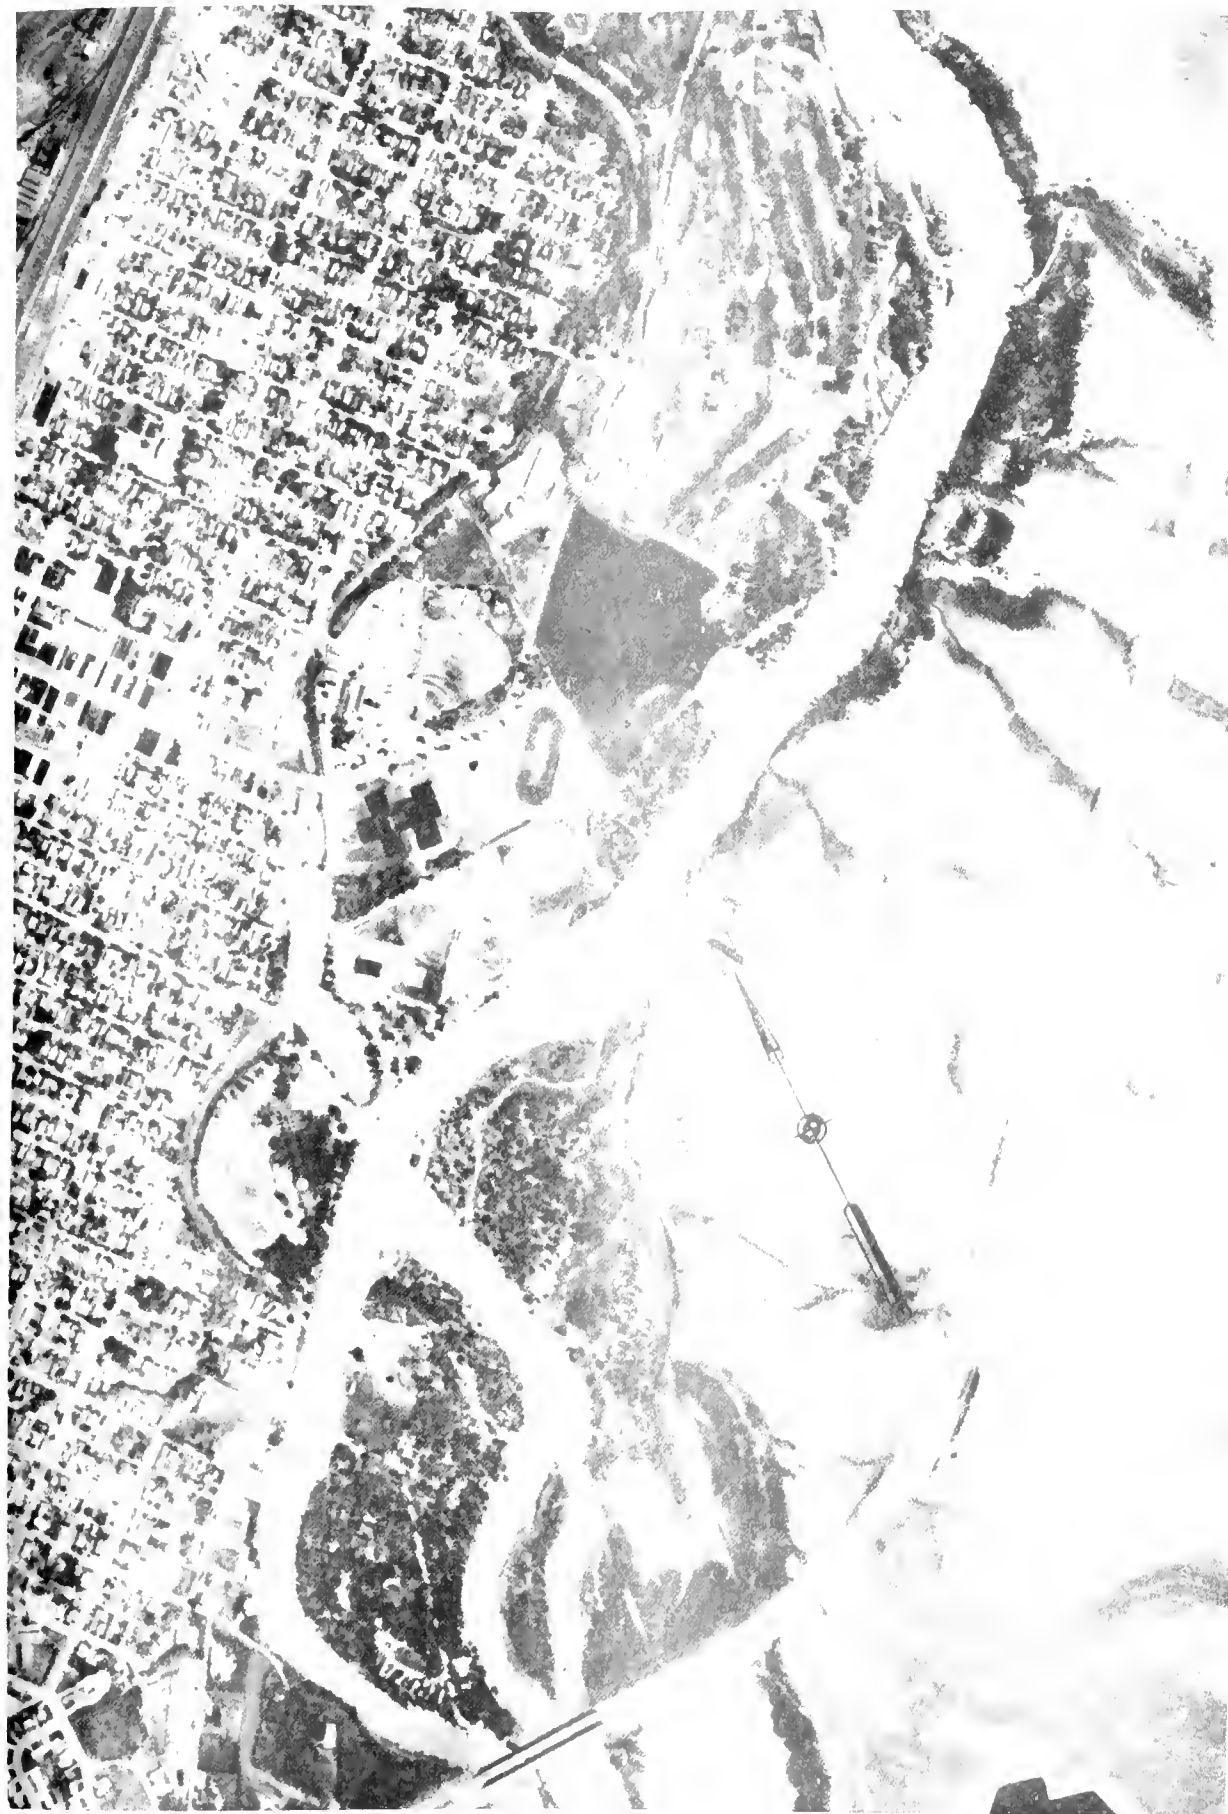
Figure 13. Yellowstone River in the vicinity of Livingston, Montana. The Interstate 90 bridge over the

Yellowstone River is at the extreme south edge of this photograph. The south edge of this photograph overlaps the north edge of the photograph of Figure 12.

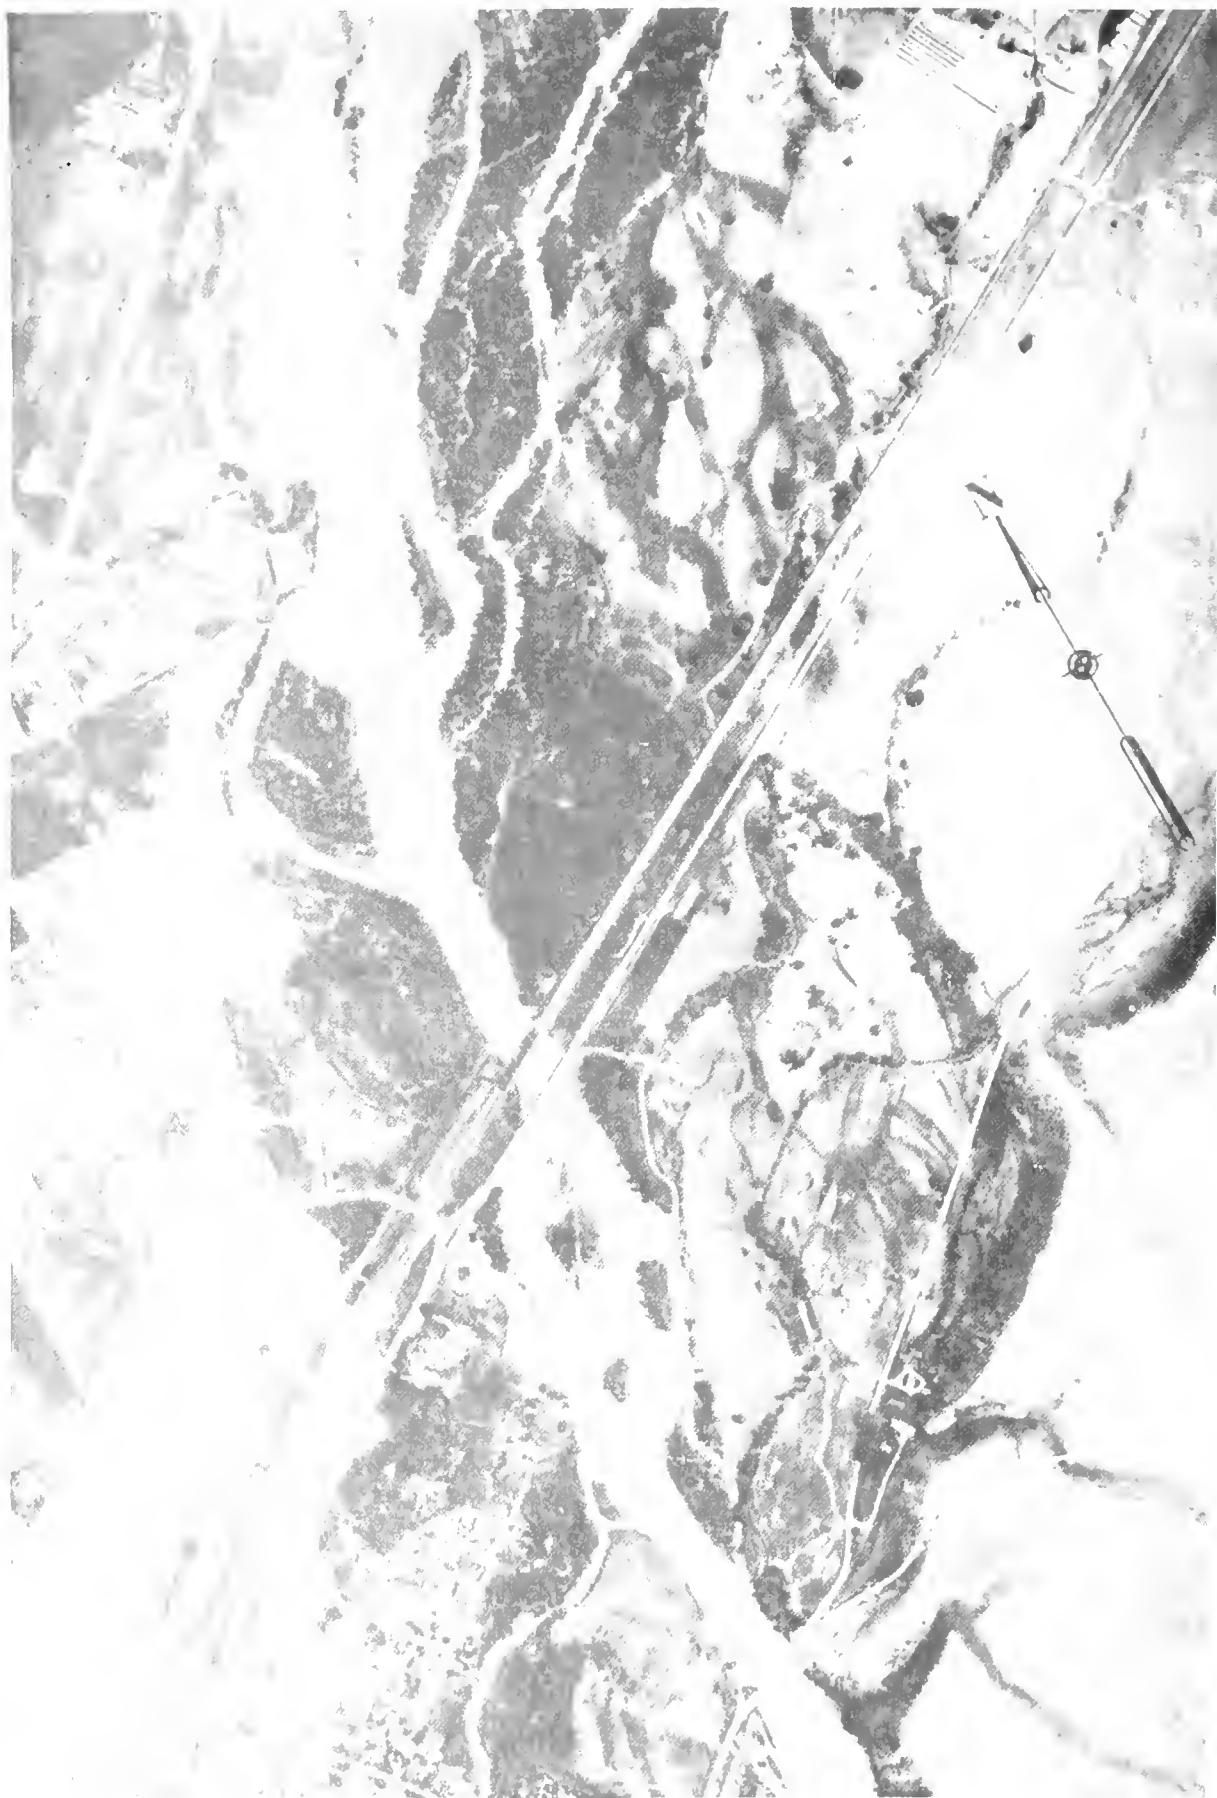
Figure 14. Yellowstone River in the vicinity of Livingston, Montana. The Burlington Northern bridge and the U.S. Highway 10 bridge over the Yellowstone River are shown in the center of the photo. The south edge of this photograph matches the north edge of the photograph of Figure 13.
